Veterans Stadium Restroom Partition Replacement Project Long Beach City College

20 April 2022

Environmental and Hazardous Material Survey Long Beach City College-Liberal Arts Campus Veterans Stadium and Ticket Booth Structures 4901 East Carson Street Long Beach, California 90808

December 17, 2021 | Project No. 210407004

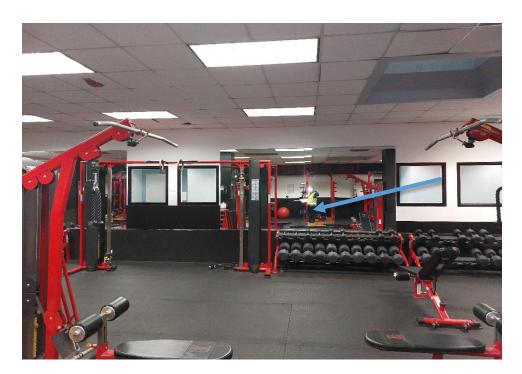
Photograph 2: View of the assumed asbestos containing mirror mastic within the gym.

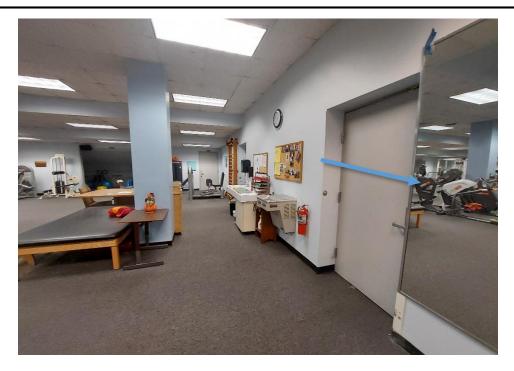
Photograph 3: View of the assumed asbestos containing mirror mastic within the adaptive facility.

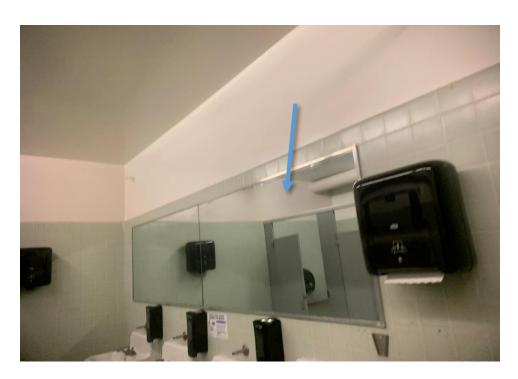
Photograph 4: Representative view of the assumed asbestos containing mirror mastic throughout restrooms.

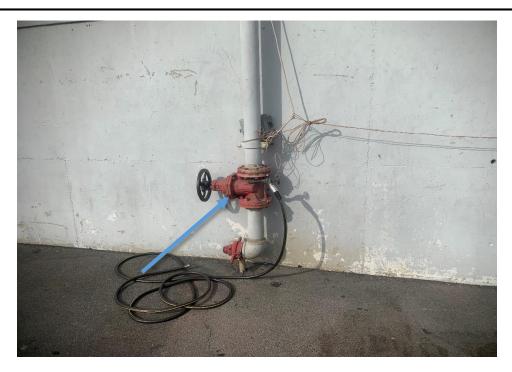
Photograph 5: View of the assumed asbestos containing pipe gaskets associated with the fire riser on the exterior southern end of the building.

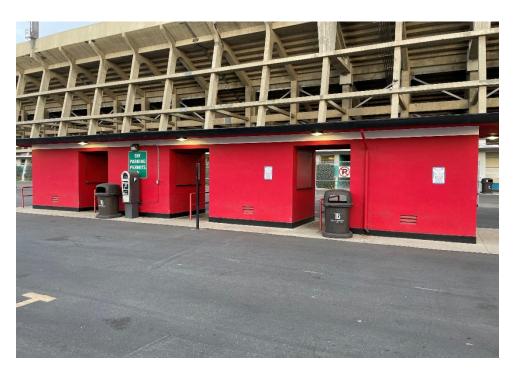
Photograph 6: View of Ticket Booth adjacent to Veteran's Stadium with asbestos containing tar and gravel roofing material.

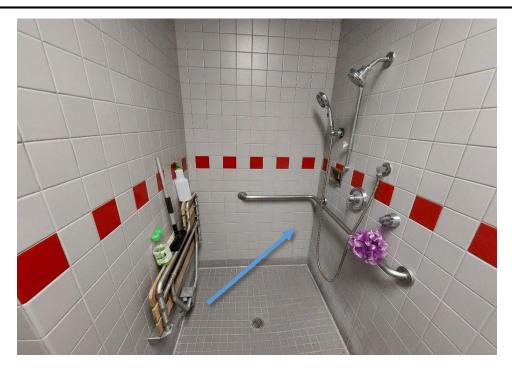
Photograph 7: Representative view of the lead containing 4"x4" Light Gray and Red ceramic wall tile in the men's & women's locker rooms.

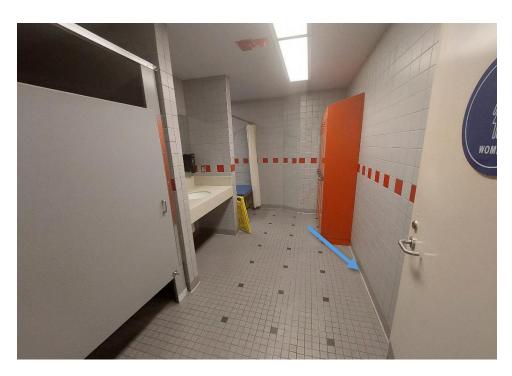
Photograph 8: View of the view of the lead containing 4"x4" gray ceramic cove base within the men's and women's locker rooms.

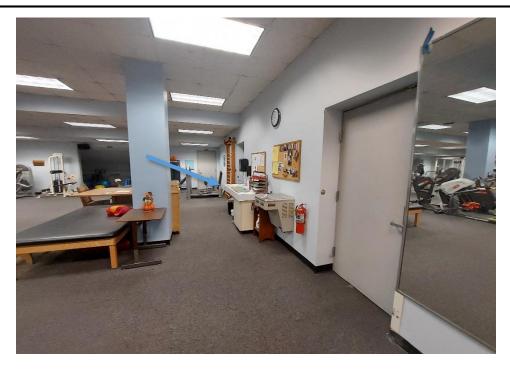
Photograph 9: View of the lead containing sink within the adaptive facility room.

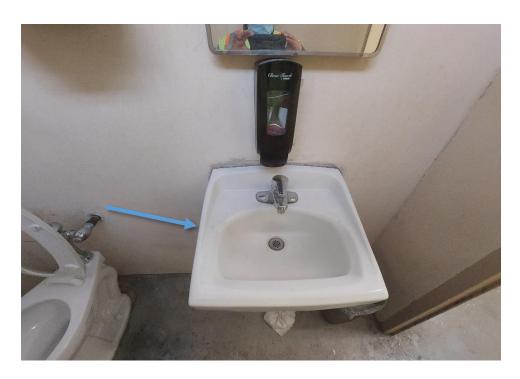
Photograph 10: Representative view of the lead containing sinks within restrooms.

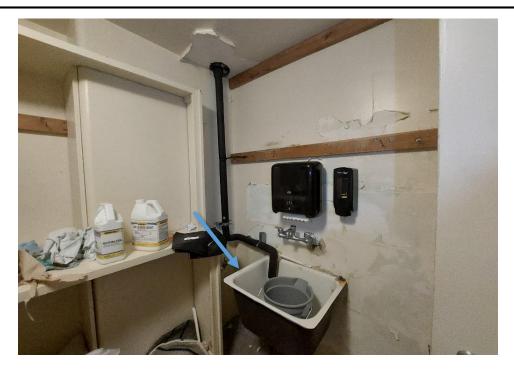
Photograph 11: Representative view of the lead containing deep sinks within janitor's closet and locker room 4 storage room.

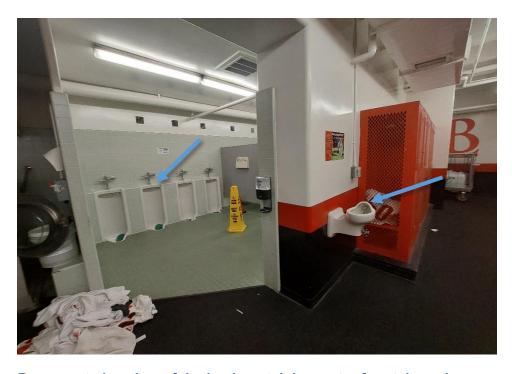
Photograph 12: Representative view of the lead containing water fountain and urinals throughout locker rooms 1-4.

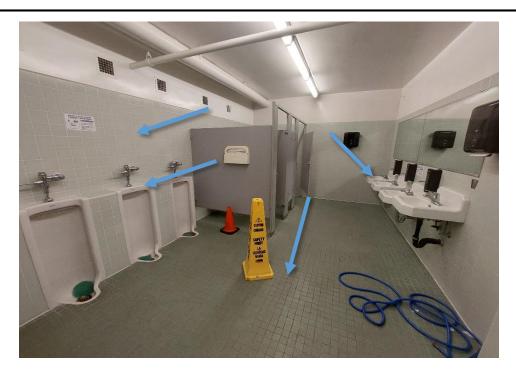
Photograph 13:

Representative view of the lead containing 4"x4" ceramic wall tile, 2"x2" green ceramic floor tile, urinals, and sinks found throughout locker rooms 1-2.

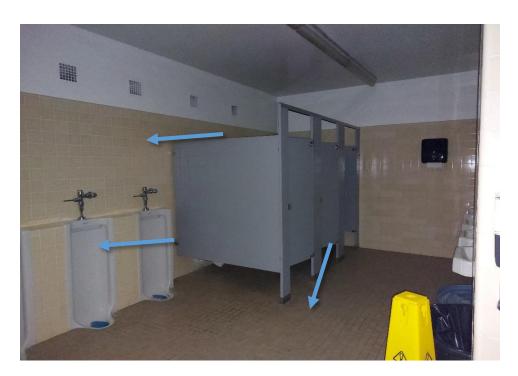
Photograph 14:

Representative view of the lead containing 4"x4" yellow ceramic wall tile, 2"x2" brown floor tile and urinals throughout locker rooms 3-4.

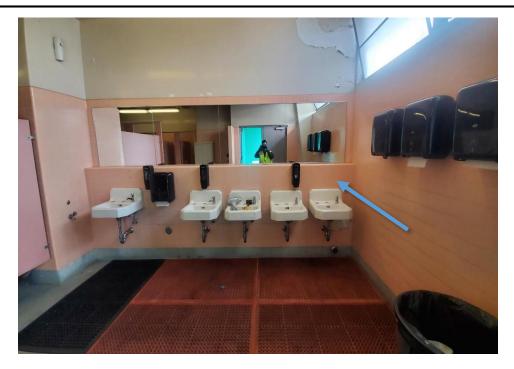
The 4" x 4" ceramic tiles in all restrooms contain lead. The lead components noted should not be disturbed by unauthorized persons. If disturbances and removal activities are planned for the components by renovation or demolition tasks, a licensed abatement contractor with certified lead personnel should perform the abatement. See Environmental and Hazardous Material Survey attached in Appendix A.

Photograph 15: View of the lead containing 4"x4" pink ceramic wall tile throughout women's restrooms.

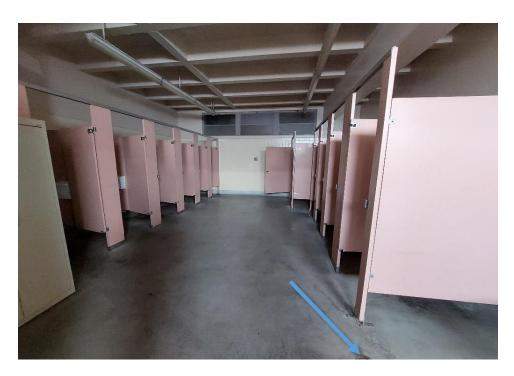
Photograph 16: View of the lead containing floor drain screen in the throughout men's and women's restrooms.

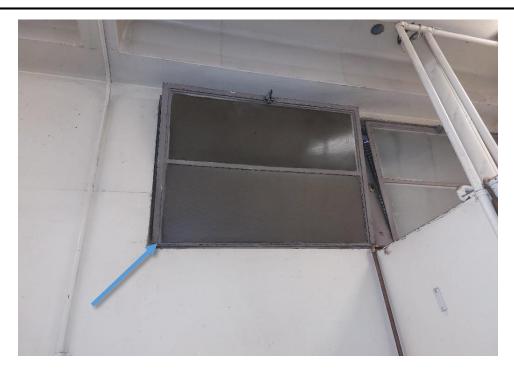
Photograph 17: View of the PCB sample location of the window putty on the exterior windows.

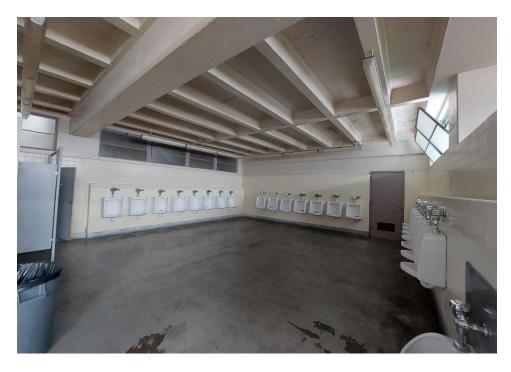
Photograph 18: Representative view of the PCB sample location of the caulking associated with the sinks, toilets, and urinals throughout.

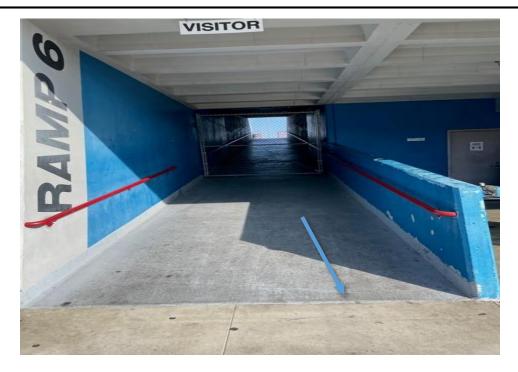
Photograph 19:

Representative view of the PCB sample location of the caulking associated with the exterior expansion joints (ramps and stadium seating throughout.

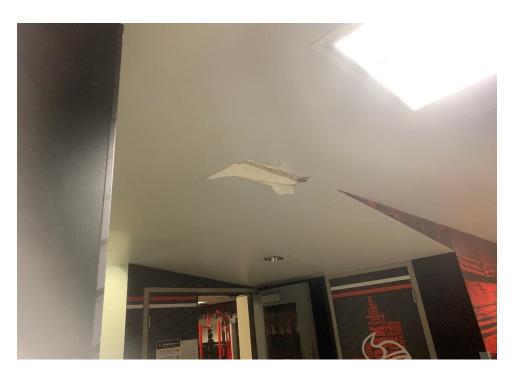
Photograph 20:

View of the water staining/damage on the drywall ceiling within the north corridor 04.

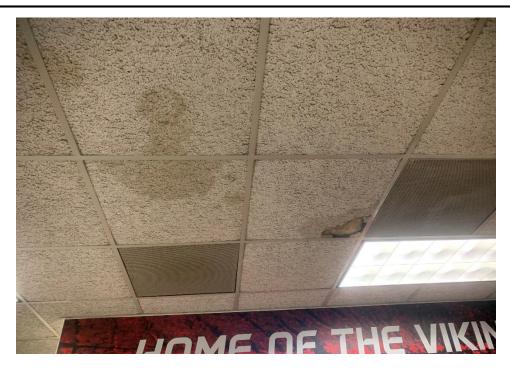
Photograph 21: View of the water staining/damage on the laid-in ceiling tiles within office 21.

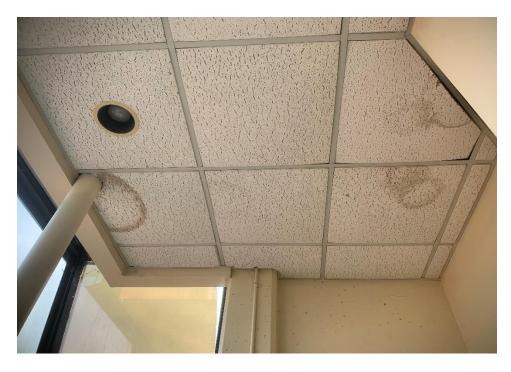
Photograph 22: View of the water staining/damage on the laid-in ceiling tiles within the press box (glued on ceiling tiles above).

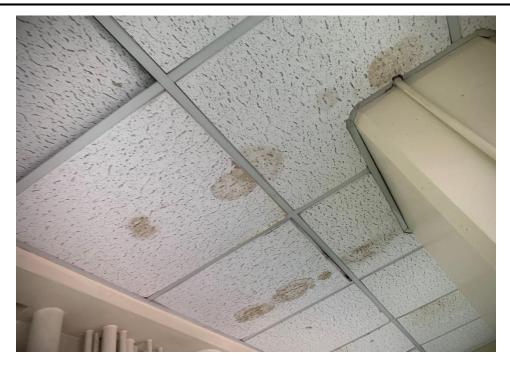
Photograph 23: View of the water staining/damage on the laid-in ceiling tiles within the press box (glued on ceiling tiles above).

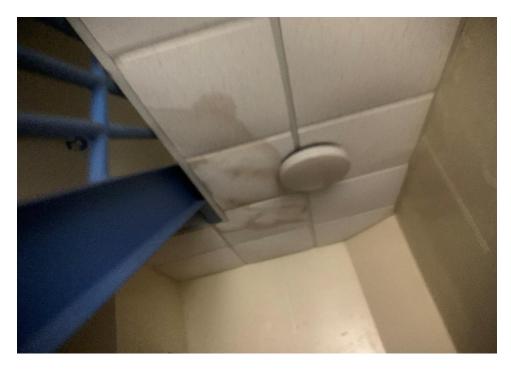
Photograph 24: View of the water staining/damage on the laid-in ceiling tiles within the press box (glued on ceiling tiles above).
